**PHYSICAL CONDITION ASSESSMENT**  
**and**  
**MAINTENANCE RECOMMENDATIONS**  
**for the**  
***SAM DAVIS HOME***

**PHYSICAL CONDITION ASSESSMENT  
and  
MAINTENANCE RECOMMENDATIONS  
for the  
*SAM DAVIS HOME***

**Prepared for the  
Sam Davis Memorial Association  
Smyrna, Tennessee**

**November 2005**

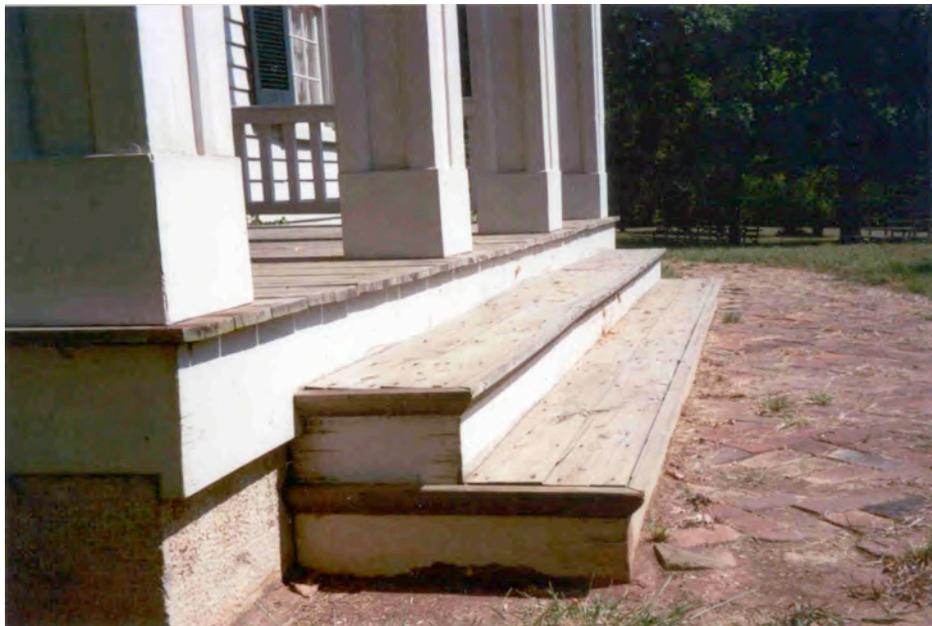
- a. The nosing moulding nailed to the front porch steps is pulling away from the treads. This is due to continuous use. As a result, small stones have fallen into the gap between the nosing and the rest of the tread. The stones need to be removed and then the nosing reattached using woodscrews of sufficient length that are then countersunk and filled.

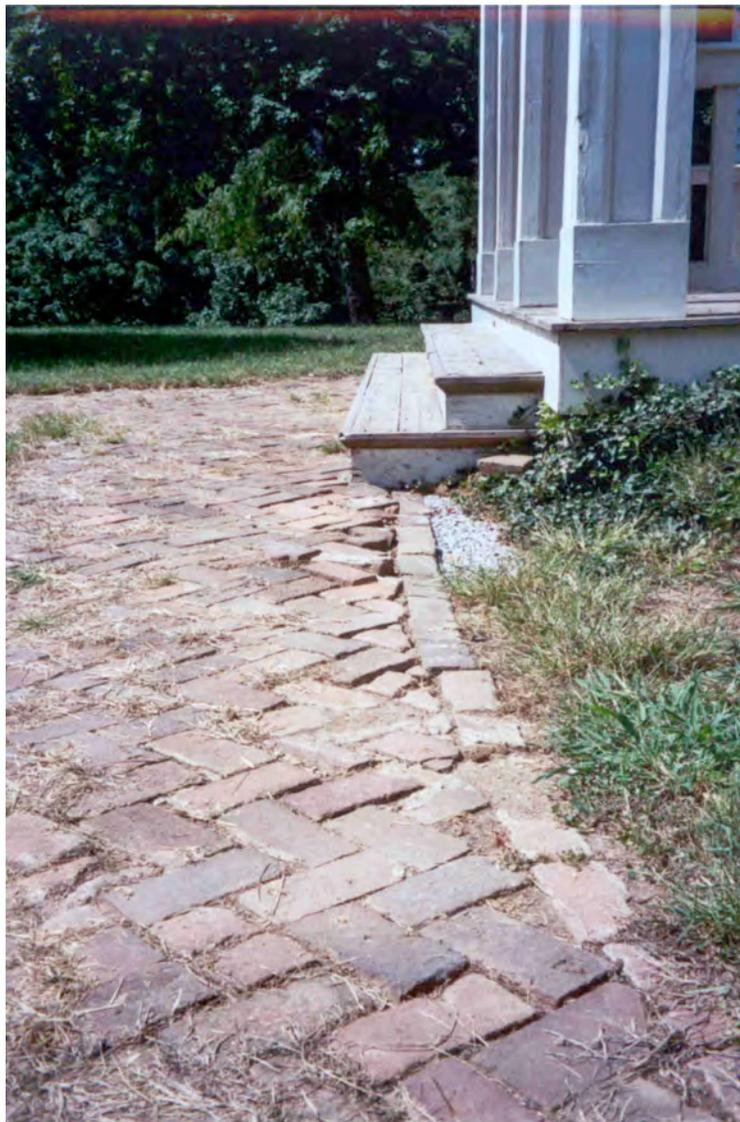
- d. A number bricks are coming loose in the walkway on the southeast corner of the house and a few are missing entirely. Grass and weeds growing in the joints are partially responsible. This situation

can be controlled by manual means or by the use of herbicide. The affected area of the walkway should be re-laid and the missing bricks replaced.

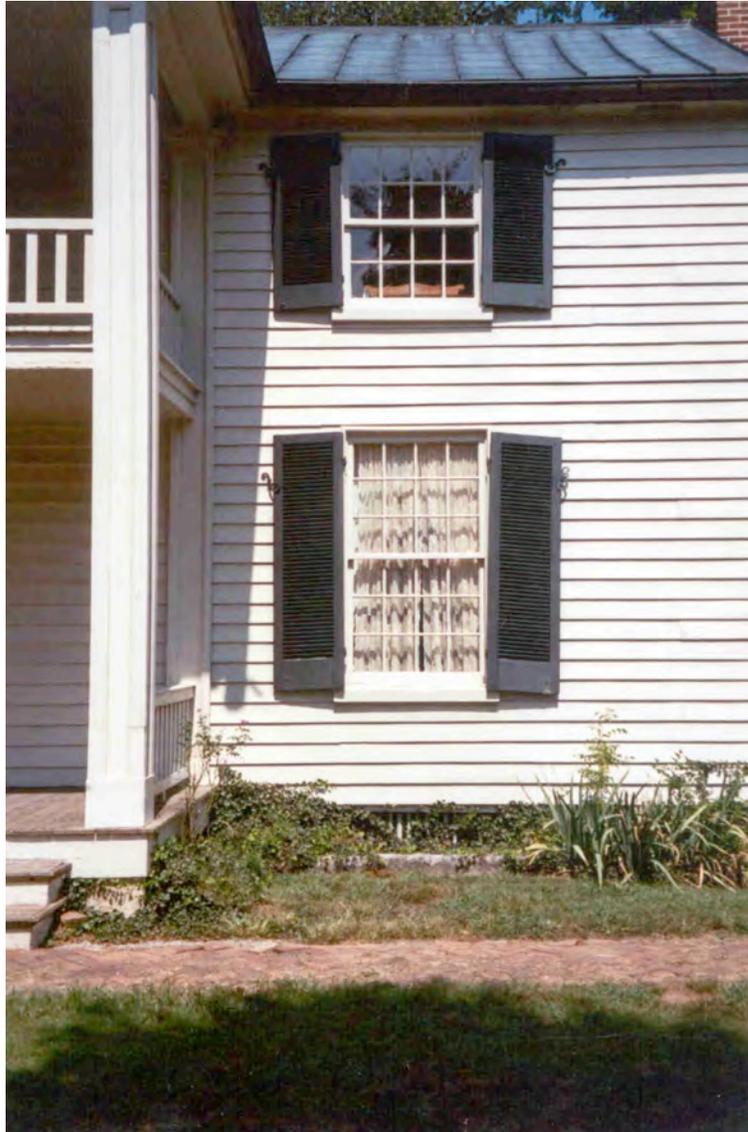
- e. The blind on the right side of one of the first floor windows on the southeast wall presents an unsightly appearance This is due to the

fact that the lower hinge of the blind has worked loose, causing the blind to sag slightly. This blind should be removed and repaired before reattaching it to the building.

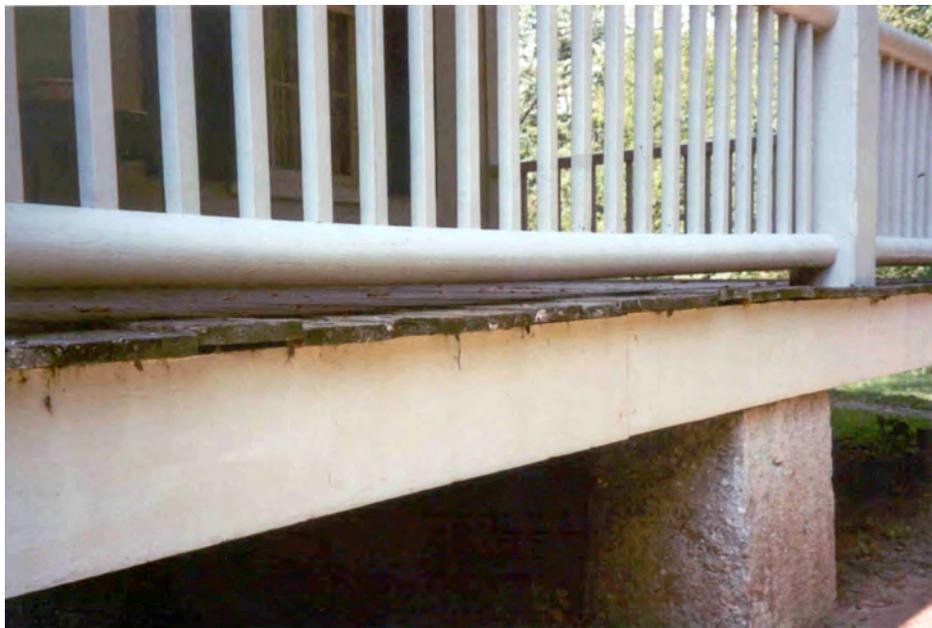
- f. On the back porch on the east side of the house, a number of the decking boards are beginning to rot near the outer edges. This too is due to continuous weather exposure. In addition, some of the framing members underneath the porch are also deteriorating. This deterioration prevents the nails in the decking boards from holding properly. The affected boards should be removed and replaced; the deteriorated framing members should be repaired. The situation in this area is similar to that of the front porch. The wood should be protected with a sealer so that it does not rot.

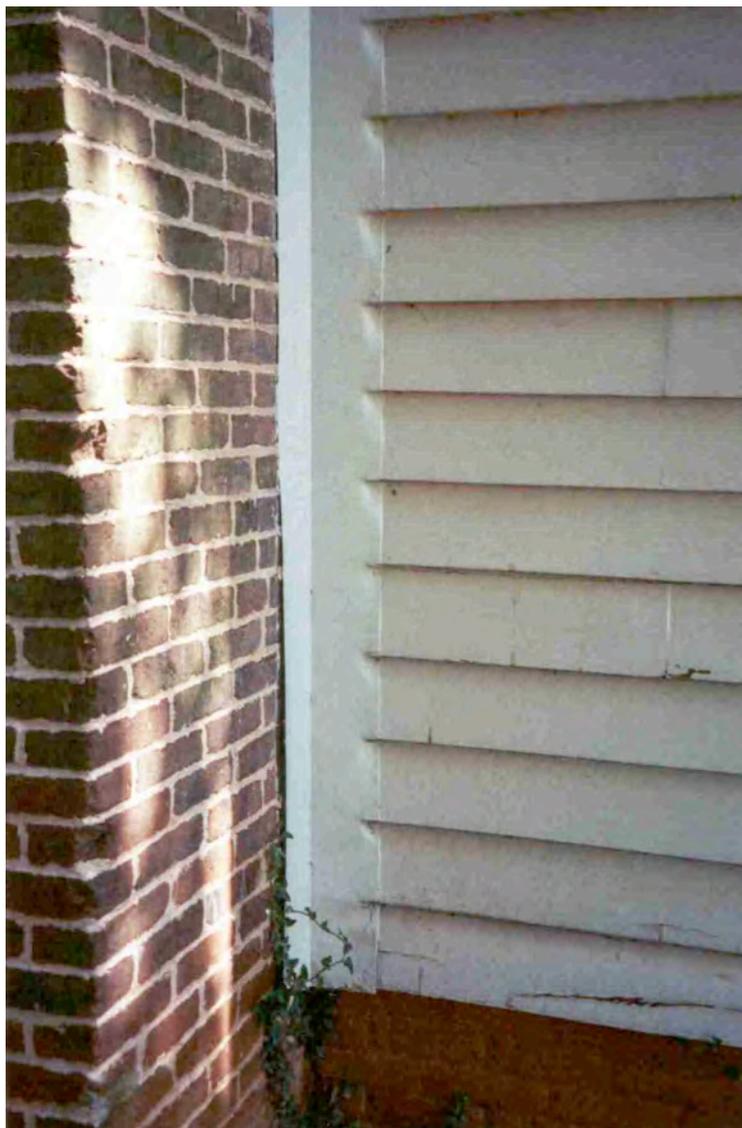
- g. In various areas around the house, the weatherboards are rotted, primarily near the ground, and specifically to the left of the chimney on the west side of the house. The deteriorated weatherboards need to be replaced with similar material and attached with historically appropriate fasteners.

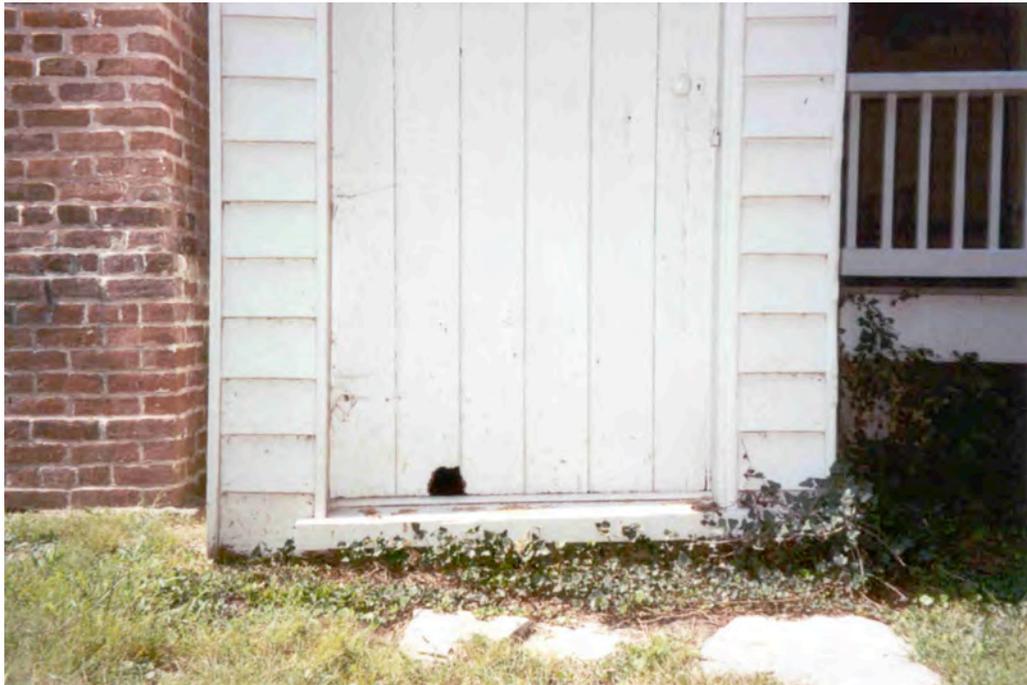
- h. On the east side of the house, a small shed protects the entrance to the basement. The bottom of the door has a large opening at the bottom evidently made by a small animal. This hole should be repaired with appropriate materials.

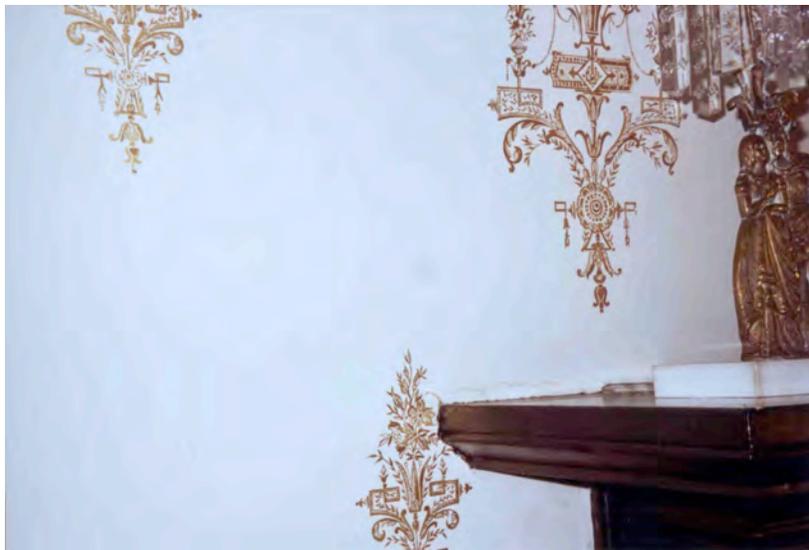
- a. This room has two main problems. First, some bricks and debris have fallen down the chimney. The chimney needs to be inspected to see what kind of material has fallen and whether or not the mortar is sound. The metal caps on the chimney should be checked to see if it is allowing birds or objects in from outside. Any missing bricks need to be replaced.
- b. The other problem in this room is that the walls appear to bow inward in some areas. This is not a major structural concern because there are solid log walls behind the plaster. However, some cracks in the paper and plaster on these walls have appeared.

This may be due to severe vibrations caused by the flights of large military aircraft at low altitude over the historic site. The proximity, intensity, and frequency of these flyovers quite likely have a deleterious impact on these fragile surfaces. It may be possible to

convince the officials at the nearby air base to redirect their flight paths away from the house. In any case, the wallpaper needs to be repaired in order to eliminate the visible cracks. It may be possible to fill these cracks carefully with putty tinted to match the color of the paper.

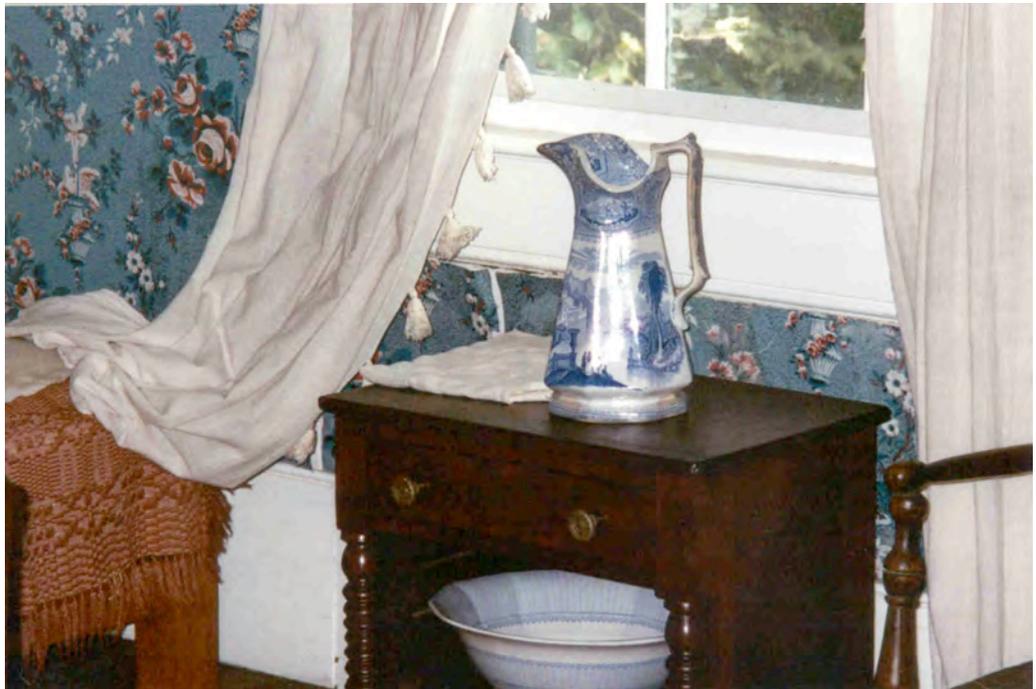
- a. There is serious water damage underneath the windows on the north and east walls of the little girl's room.

Water may be splattering in through cracks when it rains or there may be a small gap between the window sash and the frame that

water could leak through. A combination of caulking and flashing can prevent most leaks. Possibly the panes need to be reglazed. Another idea to consider would be to add an unobtrusive storm window. A few panes of glass are also cracked in this room. These panes need to be replaced.

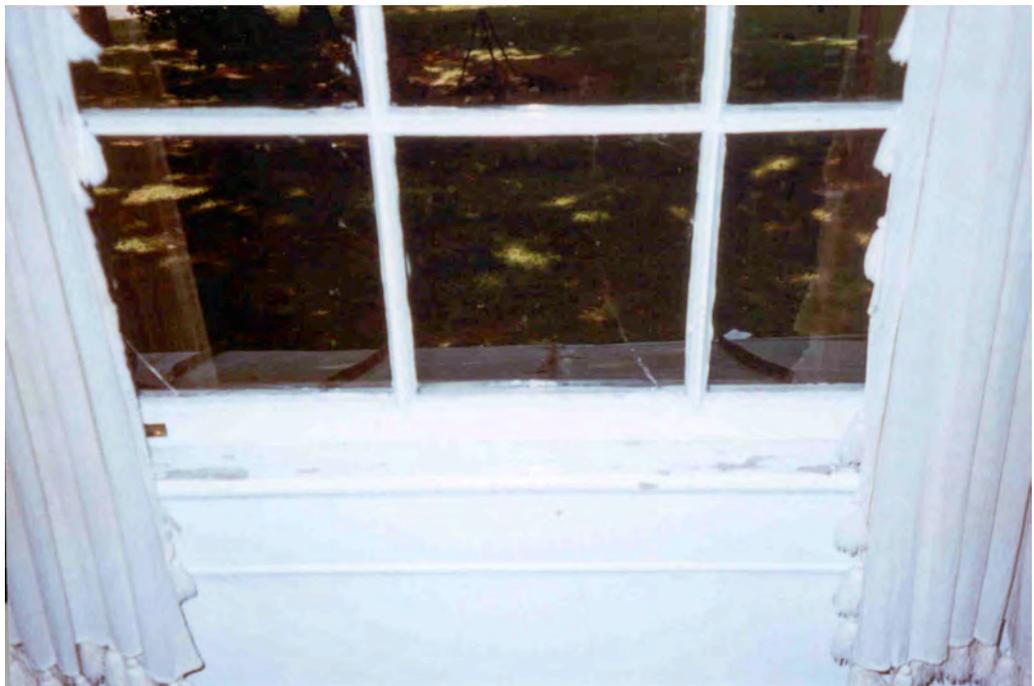
- a. The windows in the hallway on the second floor of the north side of the house also have cracked panes of glass. These panes need to be replaced.

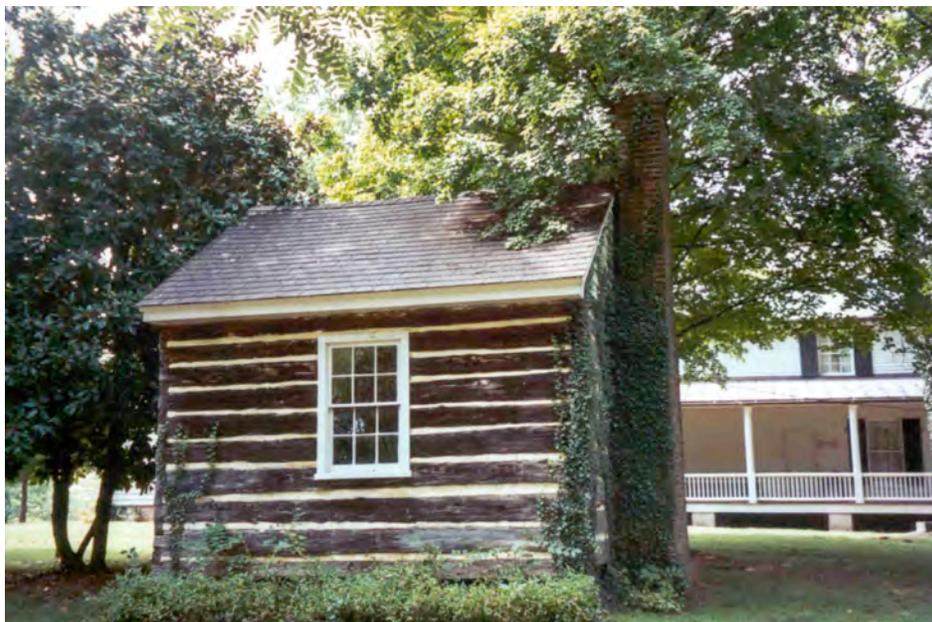
- a. Any ivy or other plant growth should be pulled off the buildings. The roots can compromise the fabric of the outer walls and chimneys.
- b. Bushes and branches should be trimmed or removed from proximity to the buildings. Any plant life close to a structure can accelerate damage from moisture to the roof, cornice, walls and adjacent parts.
- c. The wood on the east side of the former gift shop is rotting badly and needs to be replaced. The affected area should be checked for evidence of termite infestation.
- d. Care should be taken that surface rain water runs away from the buildings. The ground next to the structures should slant away at a 1 in 12 slope.
