**Preservation Recommendations
for
Palestine Methodist Church and Cemetery
Carroll County, Tennessee**

by J. Ethan Holden

AUGUST 2020

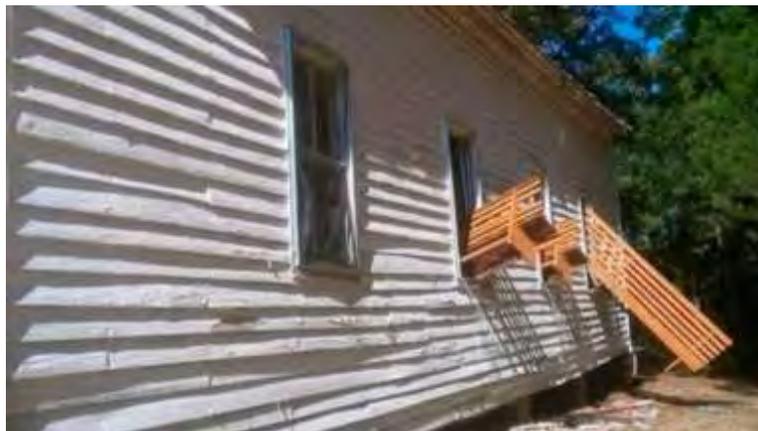
Media sources have reported three vandalism incidents at Palestine in 2013, 2016, and 2019. In September of 2013, *WWBJ7 Eyewitness News* reported that vandals destroyed nearly twenty-four headstones, in addition to leaving satanic drawings and hateful graffiti.⁸ In September of 2016, vandals again targeted the cemetery, smashing and knocking over historic tombstones.⁹ Finally, in October of 2019, vandals busted the storm windows out, flipped the piano on its side, shattered the back door, knocked holes in the floor, shoved four pews through the church windows, and busted out the windows in the front double doors.¹⁰

Figure 2. Results of 2019 vandalism, courtesy of the Carroll County News Leader

This makes identifying and implementing vandalism deterrence strategies a priority. After all, it will do little good to invest in restoring windows and repairing tombstones if they are going to be subject to vandalism in another three years. Preventing vandalism can be a difficult process, complicated by Palestine's rural location, infrequent use, and association with dark tourism and the paranormal. The following recommendations are strategies that take into consideration these factors in addition to limited budgets and reliance on volunteers.

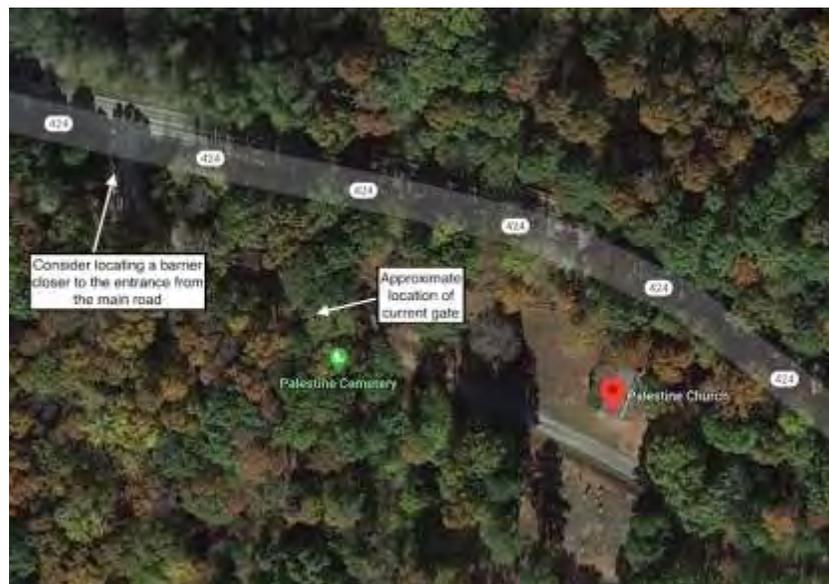
Figure 3. Aerial map showing location of extant gate and proposed location of new gate

An assessment of the entrances and their security should also be completed. Though there is a gate located near the western boundary of the cemetery, consider placing an additional barrier closer to the entrance from State Route 424 (See *Figure 3*). This can be a relatively cheap expense that may help deter vandalism. Potential vandals, deprived of parking nearer the cemetery and church where vegetation obscures visibility from the main road, would be forced to leave their vehicles in plain sight. This may serve as a deterrent and makes it easier for the patrol group to identify any vandals.

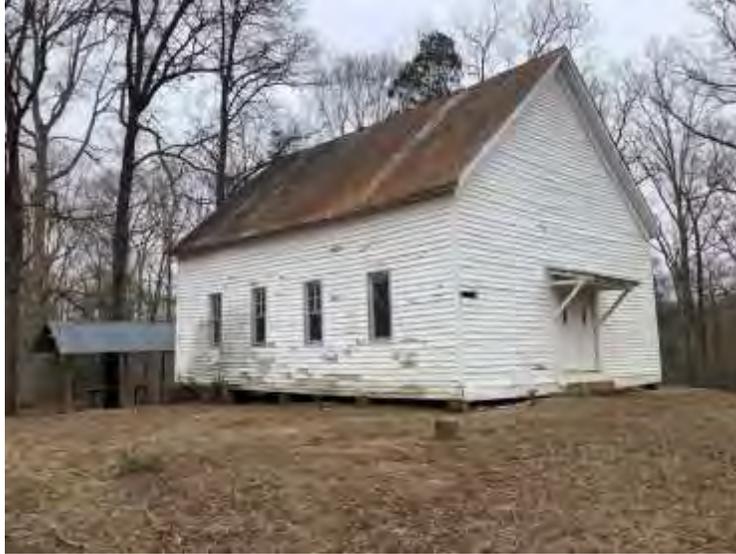
The exterior weatherboard walls should be scraped of loose paint and repainted. There are some individual boards that are deteriorated from moisture, and other small pieces that are missing. Those missing and deteriorated boards should be replaced with sound pieces of wood that resemble the thickness and shape of the original weatherboard.

Figure 4. Southwest corner of building showing peeling paint and missing weatherboard

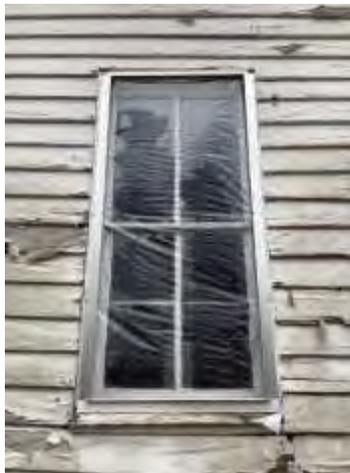
Figure 5. Broken window covered in temporary plastic

The caretakers of the property did quick work stabilizing the vandalized building as best they could by installing aluminum frames with plastic sheeting to prevent the elements from entering through the broken windows. When repairing the windows, preserve any wooden parts of the existing windows that are in good shape, and replace deteriorated parts, and wholly missing windows (as seen in *Figure 4*), with four-over-four wood frame windows to maintain the historic look of the building. Consider adding a drip cap to the top of each window to prevent water from seeping in.

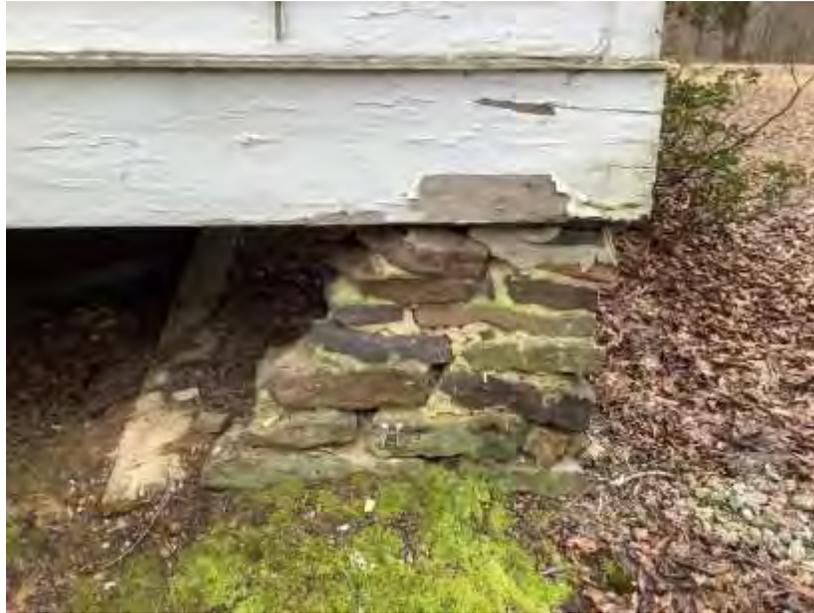
The foundation remains on top of the original stacked stone piers. The caretakers of the property have done a good job of keeping vegetation away from the sides of the building. Filling in between the stone piers or letting vegetation grow up against the building will cause moisture issues, which will accelerate the deterioration of the wooden elements of the building.

Figure 5. Stacked stone piers

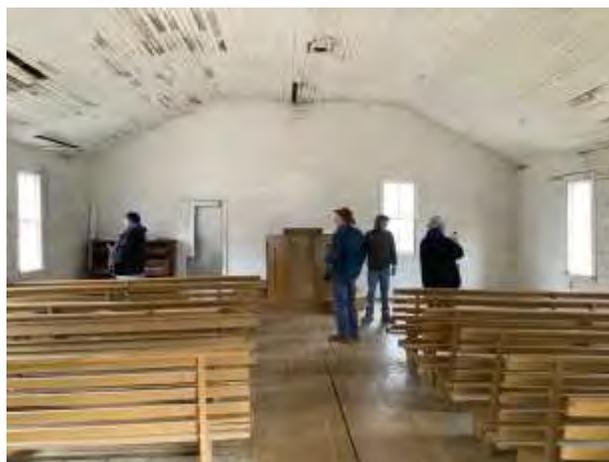
Figure 6. Interior of building

Work on the interior should not begin until the roof and windows are fixed. On the ceiling, there are areas of peeling paint, deteriorated wood, and missing boards. Missing boards and those with advanced deterioration should be replaced with boards of similar width and painted. The same guidelines apply to the boards that clad the interior walls. Mold, mildew, and peeling paint should be removed, and areas of deterioration addressed before repainting. Missing and deteriorated floor boards can be replaced with poplar or cypress planed to the same thickness as the existing boards.

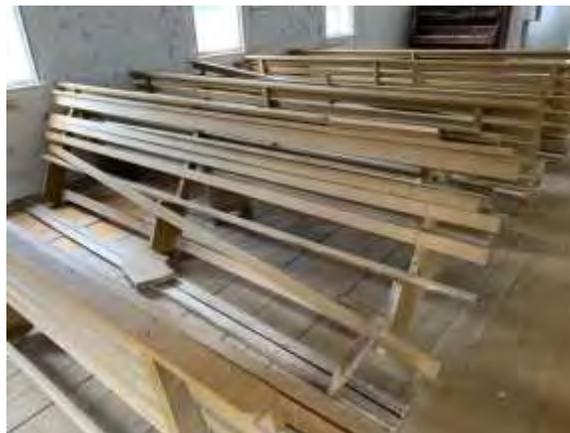
The Palestine Church building is also home to various pieces of material culture, which includes a pulpit, a piano, and pews. Here our greatest preservation concern is again vandalism. The destruction of the floorboards and continued vandalism of the piano have a strong correlation with the paranormal stories online. For example, the paranormal websites report that someone can be seen playing the piano, or that you can hear things under the floorboards. Because many paranormal “investigators” believe that you can provoke entities by damaging objects associated with them, it is not hard to see the relationship between the piano and floorboard damage. This desire to provoke entities might also play into the destruction of the pews.

Figure 1: Vandalized pews

As steps to reduce vandalism are taken, the material culture should be examined for functionality and integrity. Damaged pews should be repaired, if possible with parts from destroyed pews, though new lumber is also acceptable. Reconstruction of destroyed pews should follow the pattern of the remaining pews as best they can. If the piano is salvageable, it may be worth

contacting a professional piano tuner to come out and fix the piano. Otherwise, the friend's group may need to consider if the presence of the non-functioning piano is something they want to keep in the building.

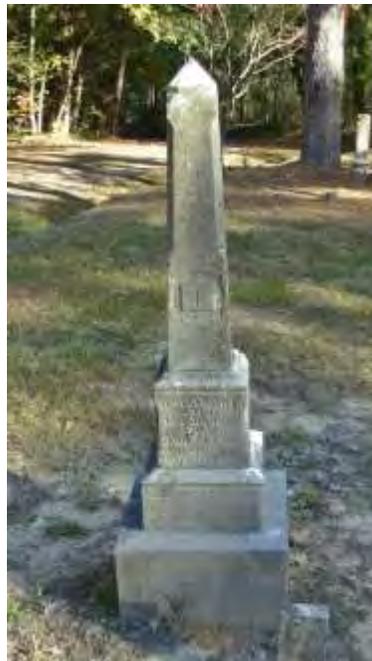
Figure 2: John Ledsinger, a missing tombstone from Palestine Cemetery. Courtesy of M.A. Gray

Another immediate step that the friend's group can take is simply to take pictures of and record the information on every tombstone within the cemetery. Though much of this has already been done, particularly on Find-A-Grave.com, having hard copies of this information can ensure that no amount of information is lost to vandalism. Indeed, several tombstones are missing from the Palestine Cemetery. If not for documentation by the community, that information would be lost.

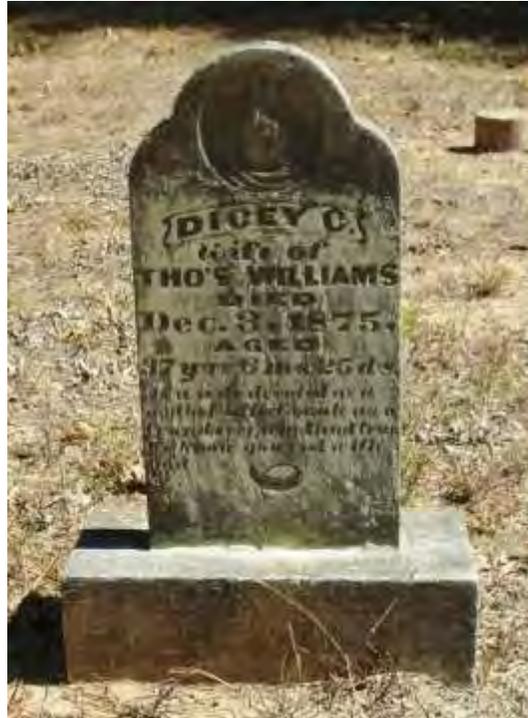
Figure 3: Dicey C.'s tombstone, another tombstone missing from Palestine. Photo courtesy of M.A. Gray

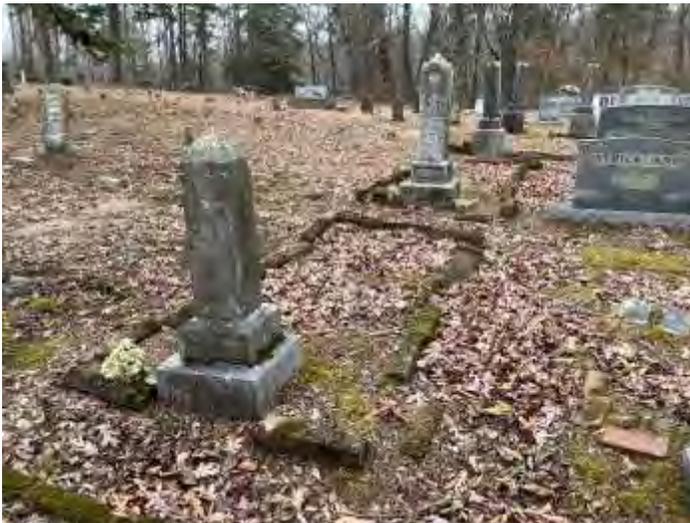
Figure 4: Graves outlined with stones and brick

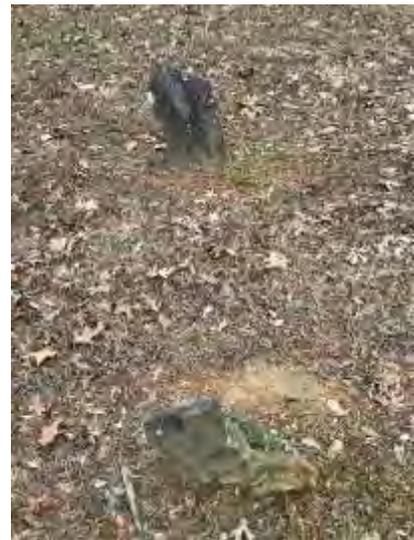
Figure 5: There are also simple fieldstones at Palestine
